Manhole Inspection Summary

Manhole # S31II1012MH

Insp Date: **3/20/07 8:13 AM**

Location Address: **TUSCANY RD**

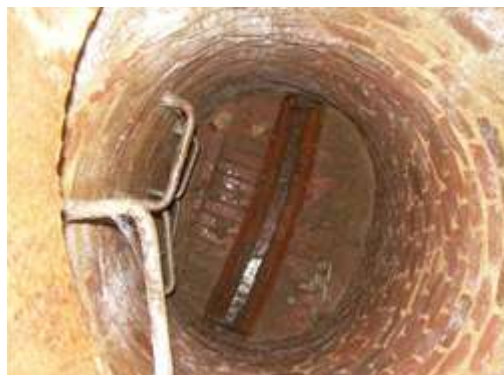
Top View

Bench debris.

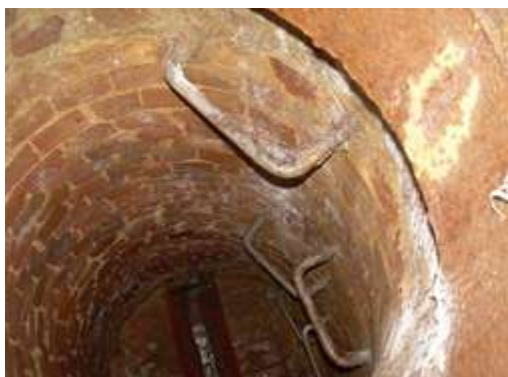
Defect

Frame leaks. Corbel infiltration.

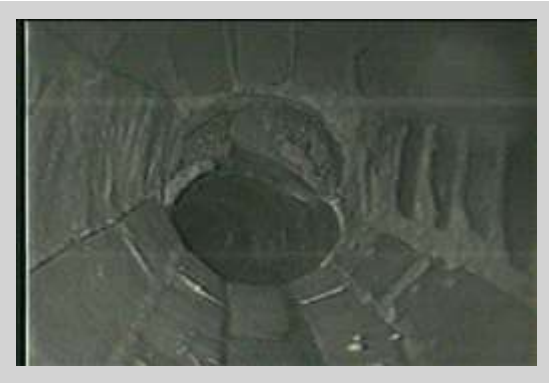
8 in. Circular Gravity Sewer Pipe Out @ 12 O'Clock

Infiltration: **Evidence** Pipe Seal Cond: **Broken**

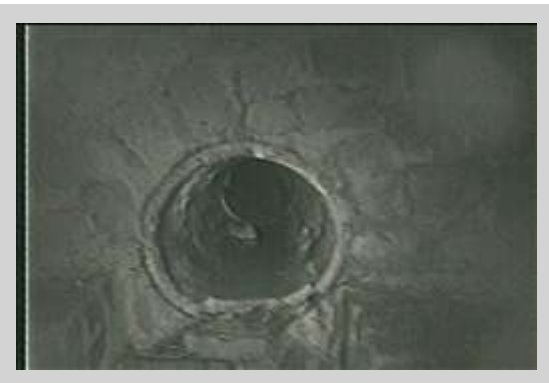
8 in. Circular Gravity Sewer Pipe In @ 7 O'Clock

Infiltration: **Evidence** Pipe Seal Cond: **Cracked**
